# Burned Metal Phenomenon: A Study of Critical Factors and Their Effects on IC Devices during Parallel Lapping

P. M. Batteate and J. Y. Liao

NVIDIA Corporation  
2701 San Tomas Expressway, Santa Clara, CA 95050  
jliao@nvidia.com  
pbatteate@nvidia.com

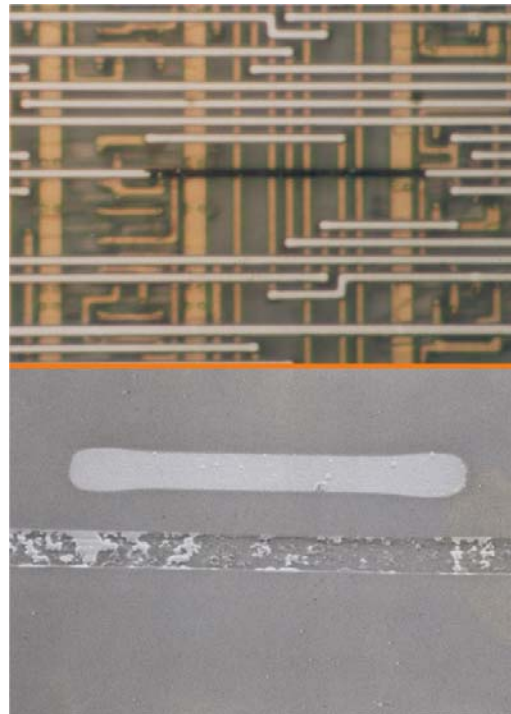
Optical micrographs and Scanning Electron Microscopy (SEM) photographs in Figures 1 and 2 demonstrate the burned metal phenomena when city water was utilized during parallel lapping. Experiment II was a repeat of Experiment I to confirm the findings. Devices parallel-lapped with DI water did not reveal any burned metal. This observation was also shown on known failed devices subjected to parallel lapping with DI or city water (Experiment III).

After analyzing the results of these three experiments, we conclude that heat has no effect on the metal. However, the samples that were subjected to parallel lapping with city water revealed corroded metal. To study the effect of water during parallel lapping, we engaged Balazs Analytical Laboratory to perform the analysis of water quality. Upon receipt of the results, a fourth experiment was conducted to better understand the corrosiveness of chlorine to aluminum metal lines on ICs.

Figure 1: Optical (upper) and SEM (lower) micrograph showing burned metal. The sample was prepared at room temperature and city water was utilized in parallel lapping.

These experiments demonstrated that additional burned metal observed on areas of the die not pertaining to emission locations was caused by the high concentration of chlorine in city water. Consultation with representatives of Balazs Analytical Laboratory indicated that a single digit reading of chlorine is enough to cause corroded metal. City water contains 70ppm, well over the limit, while DI water contains only 0.10ppb.

Based on the experiment results and analyses, we have converted all polishing wheels to use DI water only. Hence, burned metal phenomenon on areas not confirmed and validated with electrical fault isolation procedure was no longer experienced.

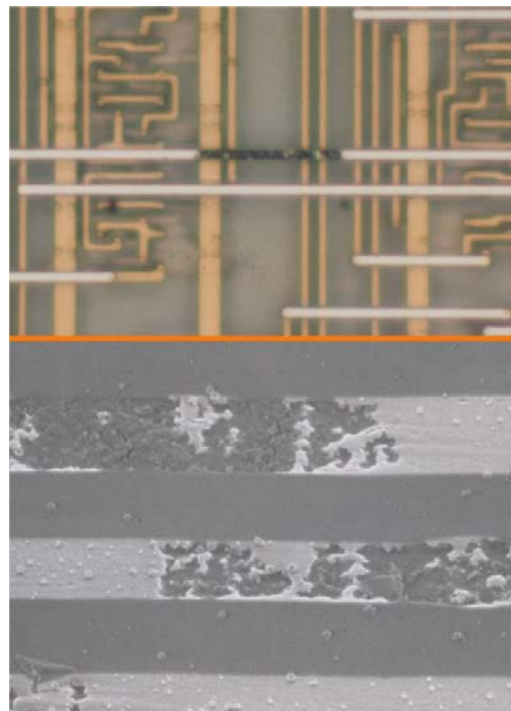
Figure 2: Optical (upper) and SEM (lower) micrograph showing burned metal. The sample was prepared at elevated temperature and city water was utilized in parallel lapping.

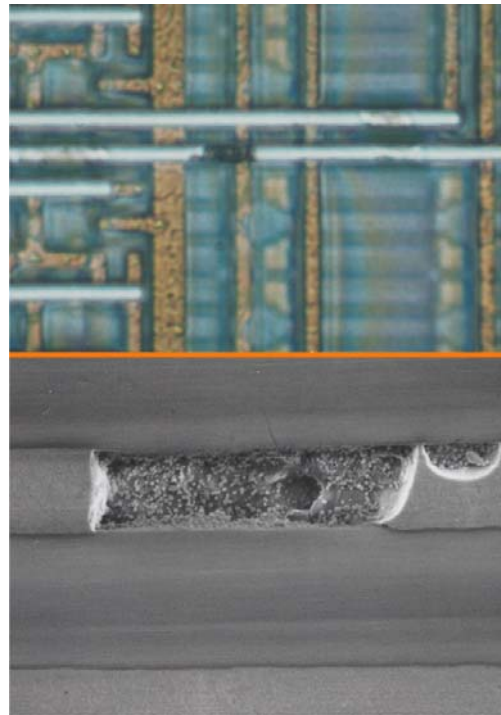
techniques is known to be real and true, caused by electrical overstress of the devices. Figure 3 shows an example of burned metal resulting from electrical overstress.

Figure 3: Optical (upper) and SEM (lower) micrograph showing burned metal resulting from electrical overstress.
